This Report Has Been Prepared Exclusively For: Linda Wyman

Property Address: 3900 W Hooker, Seattle, WA
Date of Inspection: 3/24/2007 Start Time: 3:15:00 PM Report Number: 032407-3

Exterior / Roof Survey Findings:

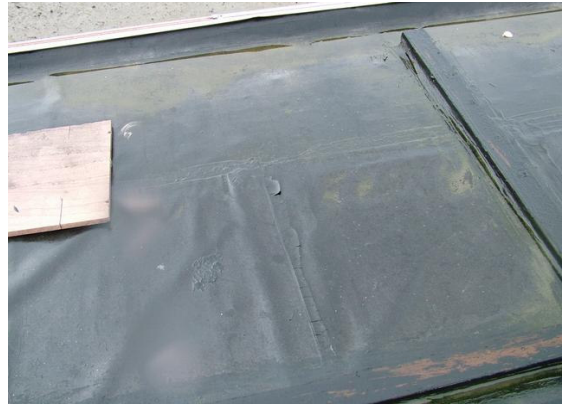
Photo: 1010 (1)

[R] 1010: Roof cracked buckled, Recommend review of entire roof by licensed contractor, repair as necessary

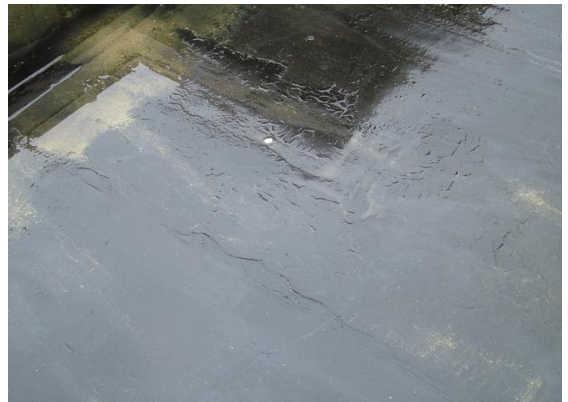
Photo: 1060.02 (1)

[F] 1060.02: Roofing material appears to be lifting.
See series 1060.02 photo(s)

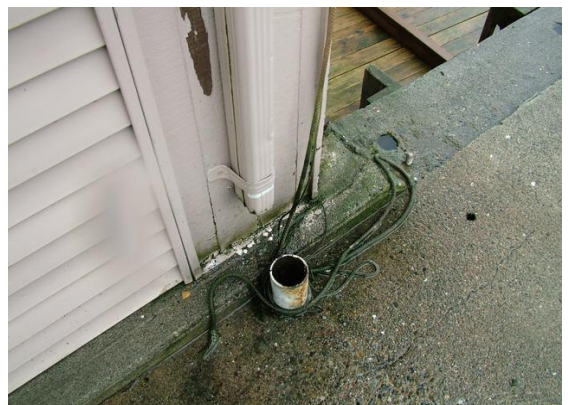
Photo: 1280.10 (1)

[F] 1280.10: Downspout not connected.

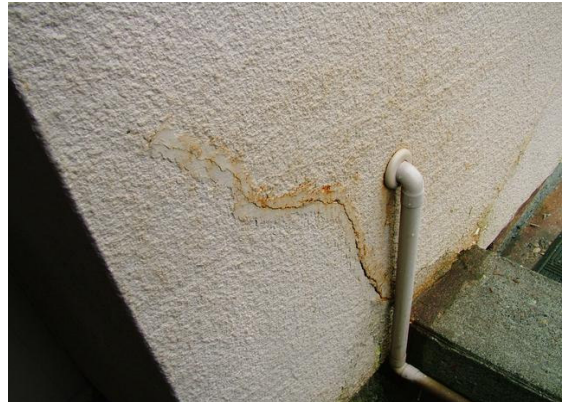
Photo: 1400.01 (1)

[F] 1400.01: Stucco cracked. Any cracks may allow water to enter the wall cavity which may cause fungal growth (mold) or wood deterioration. The inspector cannot ascertain the condition behind the wall covering.
See series 1400.01 photo(s)

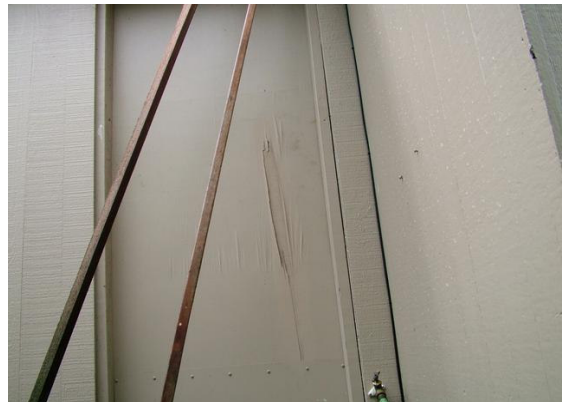
Photo: 1620.01 (1)

[F] 1620.01: Door weathered. (garage)

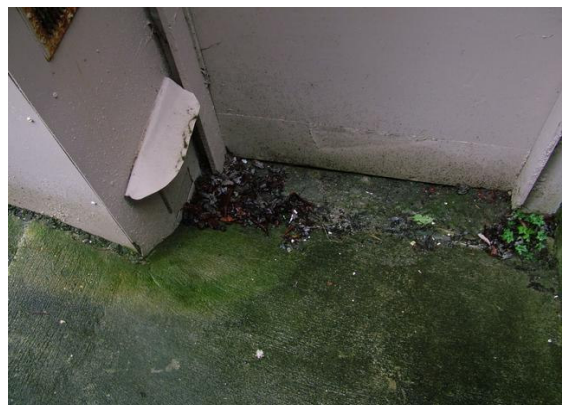
Photo: 1950 (1)

[F] 1950: Drain needed by shop door to prevent water from infiltrating into the basement.
See series 1950 photo(s)

[F] 1950: Downspouts do not extend into the drains.
